REFINERIA DI KORSOU TECHNICAL AUDIT REPORT

Executive Summary

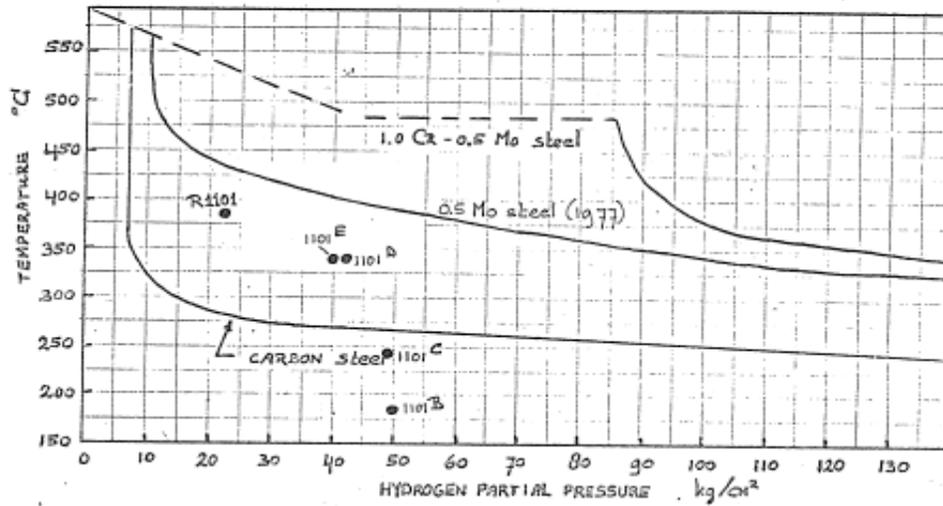
Figure 2.3 1977 - Nelson Curves (Operating Limits for Steels in Hydrogen Service)

The second major threat may be also the risk of HTHA at the hot end of the Feed/Effluent exchanger E1101 bank, shells D and E, which are also made of C-0.5Mo. These units have been identified as operating above the CS line, which also represents the C-0.5Mo material, Fig. 2.3 originates from RDK/ISLA files. Lowering of the Nelson curve may bring the E-1101-C into the non-recommended zone if some non-PWHT welds (new or repairs) have been installed. The same argument concerning material testing as the one indicated for the R-1101 case applies for the hot components of these exchangers. Due to the lower thickness of the components and gradually lowering temperature gradient the probability and of damage may be somewhat less compared to the Reactor. This, however, would not eliminate the need to address this potential issue.

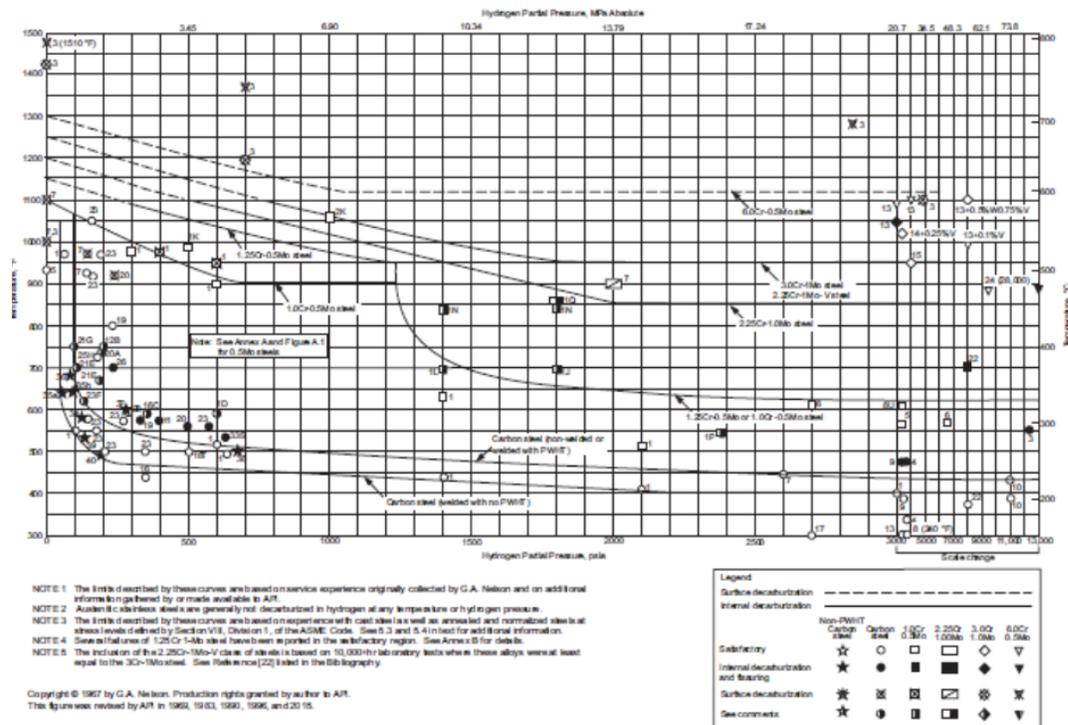
Figure 2.4 Operating Limits for Steels in Hydrogen Service to Avoid High Temperature Hydrogen Attack

For comparison the latest curves from API RP 941 are shown below in Fig. 2.4. The drop of the curve for non-PWHT CS may result in inclusion of equipment, which has been considered in the past to be operated in a “safe zone”.

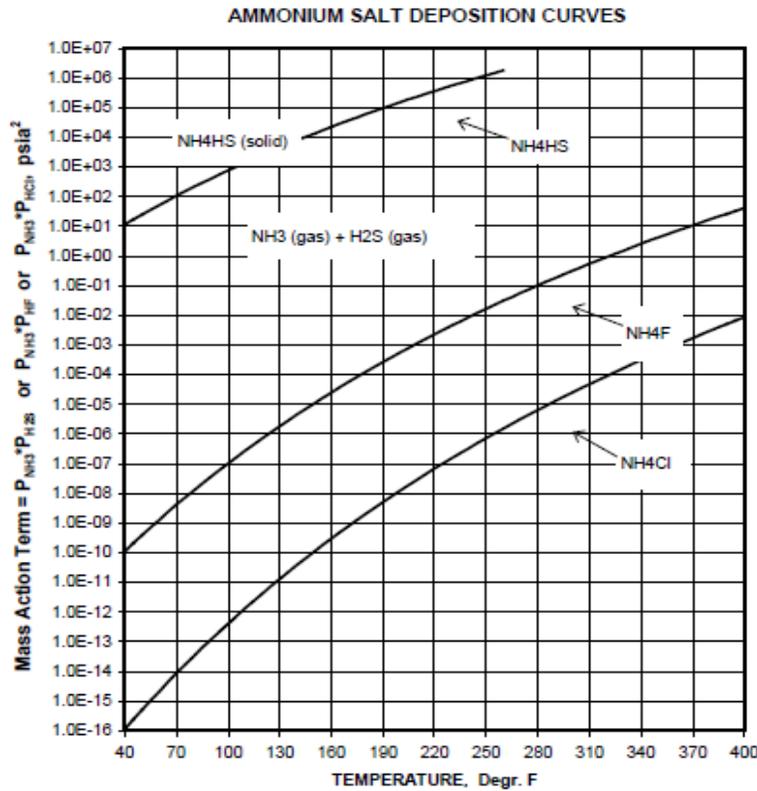
Figure 2.5 Ammonium Salts De-sublimation Curves

Cold end of this E-1101 exchanger bank (units A and B) appear also to suffer from ammonia chloride salt fouling and corrosion. Refer to the de-sublimation curves shown below in Fig.2.5 to estimate the corrosion potential. More discussion is provided in section 6 – VGO-MHC Unit.

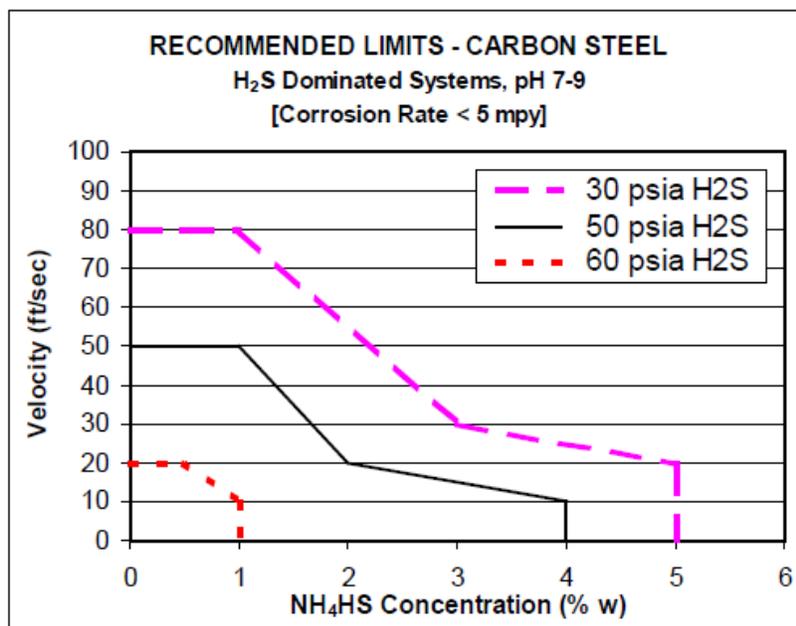
Figure 6.1 Targets for ammonium bisulfide corrosive parameters, acceptable corrosion rates

First integrity risk could be the condition of the cold end of the REACS (Reactor Effluent Air Coolers) E1502. Corrosion is not well controlled nor the inspection program able to assess their condition adequately. REAC

corrosion is a weak spot of most hydrocracking units and should be receiving close attention. Corrosion in these systems can be localized and at times severe. The most frequent damage is caused by Ammonium Chloride salt deposits or Ammonium Bi-sulfide in high velocity and turbulence areas. Numerous failures have occurred in these REAC systems. Since information on the precursors to the corrosive compounds hasn't been available we could not quantify the corrosion risks. Water wash is commonly utilized to dilute or prevent deposition of the ammonium salts but its effectiveness depends very much on the injection system design and operation and wash water application and quality. Guidelines for design and operation of such systems are available. We did not locate comprehensive design data for this WW system. Example of targets for acceptable corrosion rates are shown below in Fig. 6.1

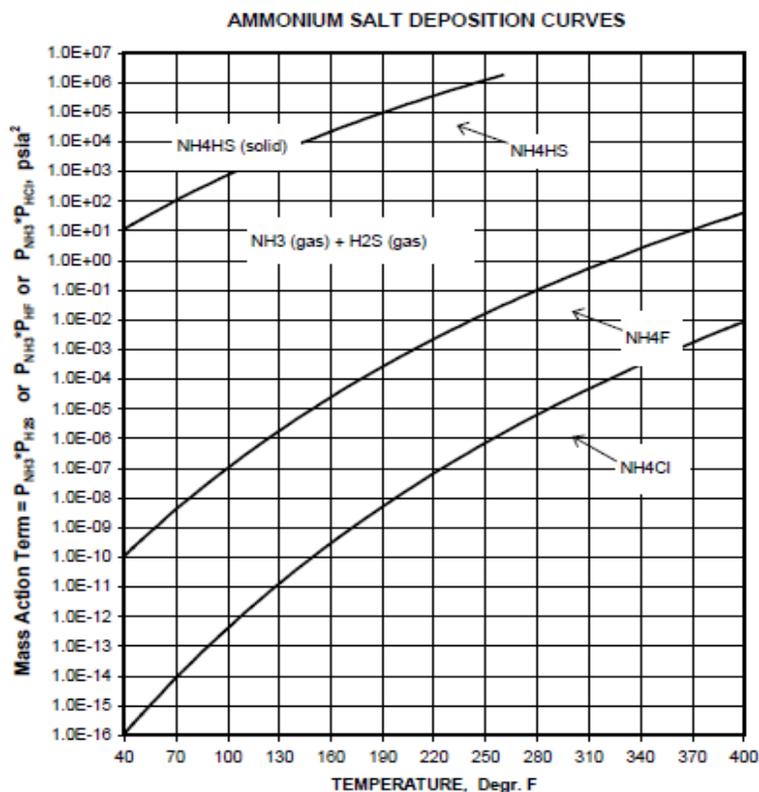
Figure 6.2 Ammonium Salts De-sublimation Curves

Proper data are needed to assess corrosion risks in these systems accurately. For example of ammonium salt deposition curves refer to the Fig. 6.2 below. These are approximate; more flexible and more accurate models are available.

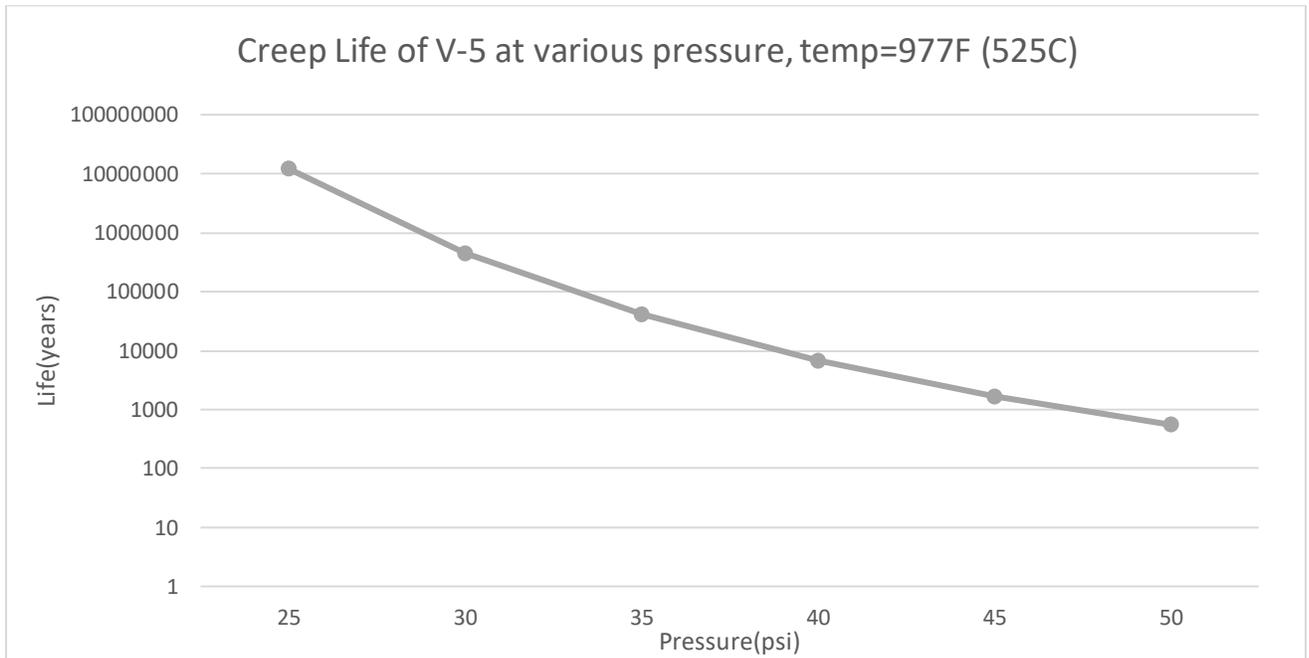
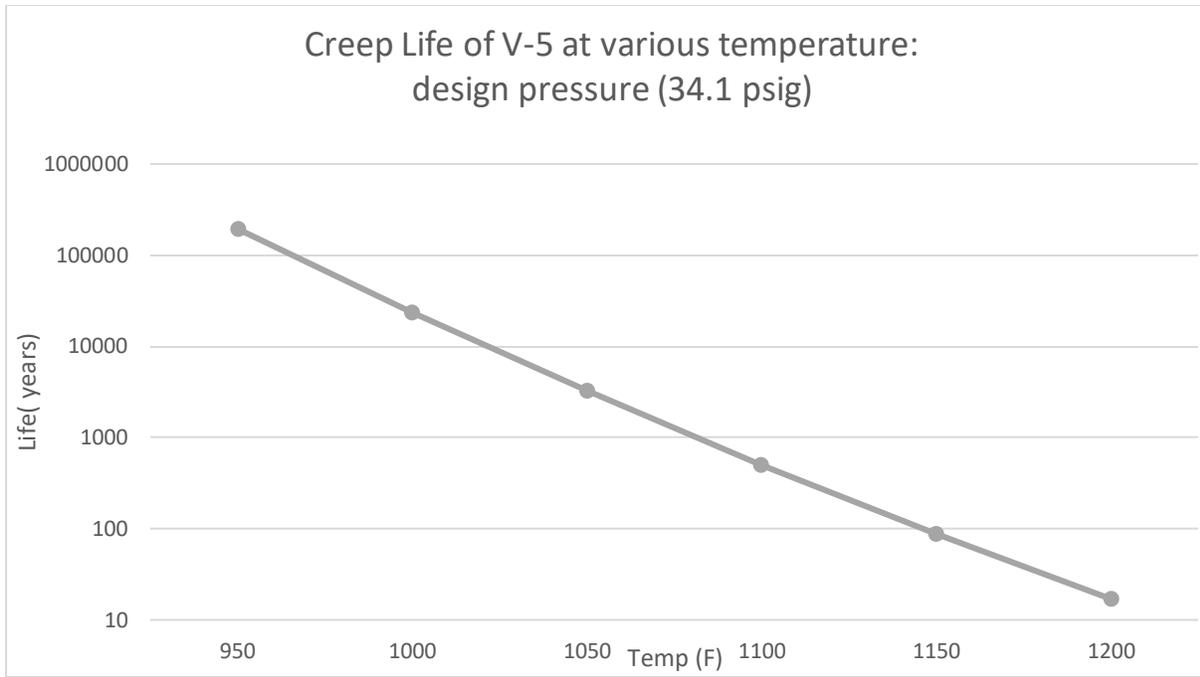
Remaining life can be estimated more accurately when real material data and operating history are given. Since we could not find the relevant data, a sensitivity analysis was done for various temperature and pressure range. E&D Technologies developed a computer program to estimate the remaining life based on API 579. Results are shown in figures 2 and 3. As shown in the figures, plenty of remaining life is expected if the vessel is operated within the design limit.

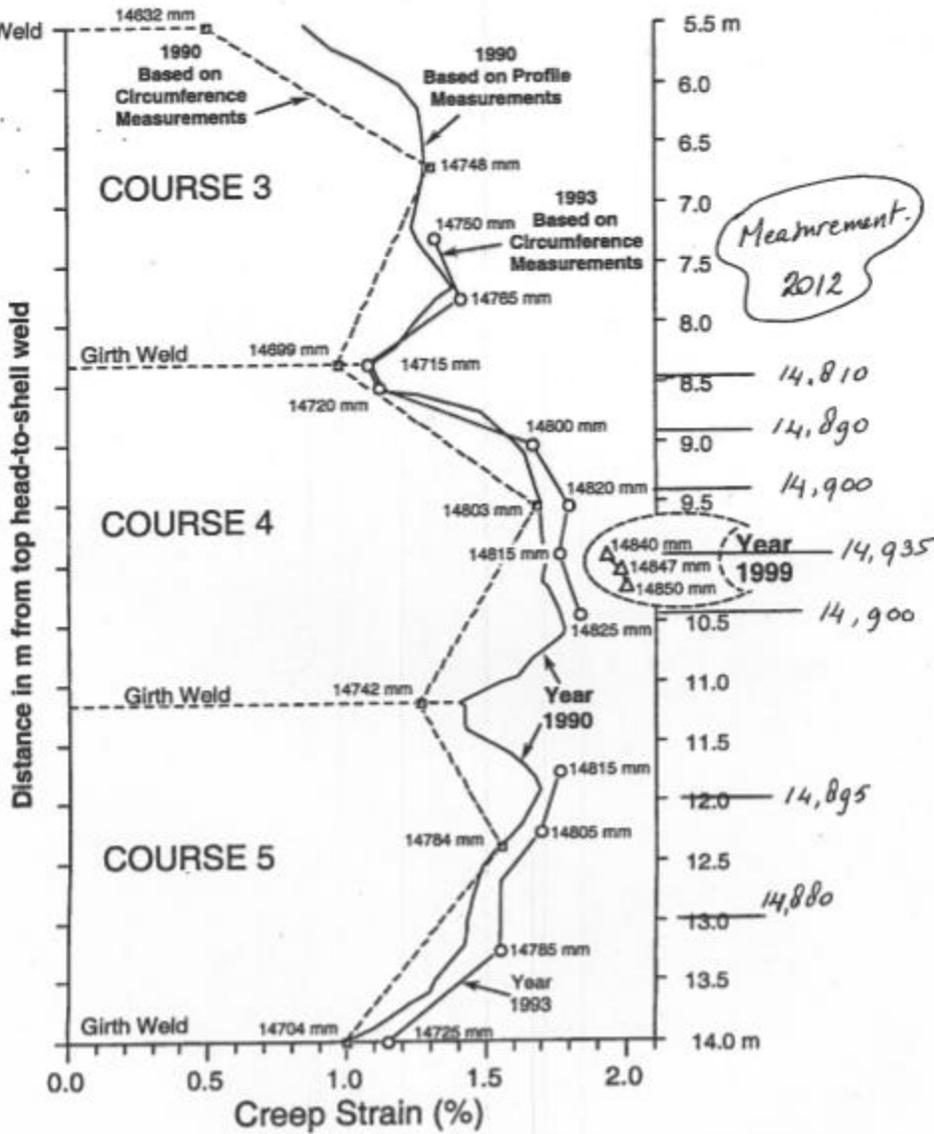
Figure 2. This is Figure 3.46 of the technical report INT-6024,1999. It shows the evidence of growth measured since 1990. Compared with the 1999 measurements, this represents a maximum of 0.28% growth in 9 years of service, equivalent to 0.031%/year creep rate.

*Original circumference 14,559
measured adjacent to the top/bottom heads.*
