REFINERIA DI KORSOU TECHNICAL AUDIT REPORT

Executive Summary

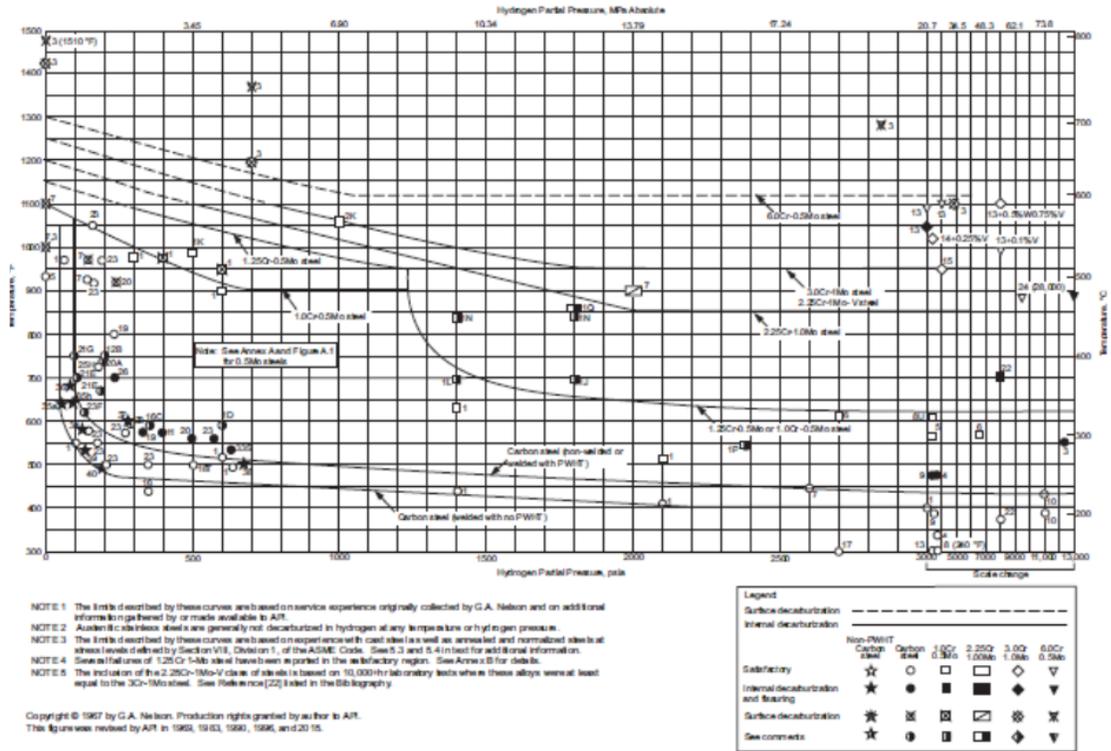
Equipment at risk of elevated temperature corrosion (Sulfidic or naphthenic acid)		<p>While the refinery appears to have an effective program for monitoring for elevated temperature corrosion in the NHT it should be noted that the 5% Cr piping materials associated with the charge heater a likely much less resistant to corrosion than the designers understood. The Couper-Gorman curves used for predicting corrosion rates due to H₂/H₂S gives no more credit for resistance of 5% Cr materials to corrosion than carbon steel. In such cases, it is recommended that at least 9 Cr materials be used.</p>
Equipment requiring Inspection for CUI	Feed to Effluent Exchangers, E-1301 and 1302.	<p>Given the temperature range of the shells and channel heads, these exchangers are likely susceptible to CUI. There is no documented evidence that any CUI inspections have been conducted.</p> <p>Recommendation: Perform a thorough CUI inspection of these shells and channel heads.</p>

Figure 5.2 Operating limits for steels in hydrogen service to avoid HTHA (ref. API RP 941 Figure 1)

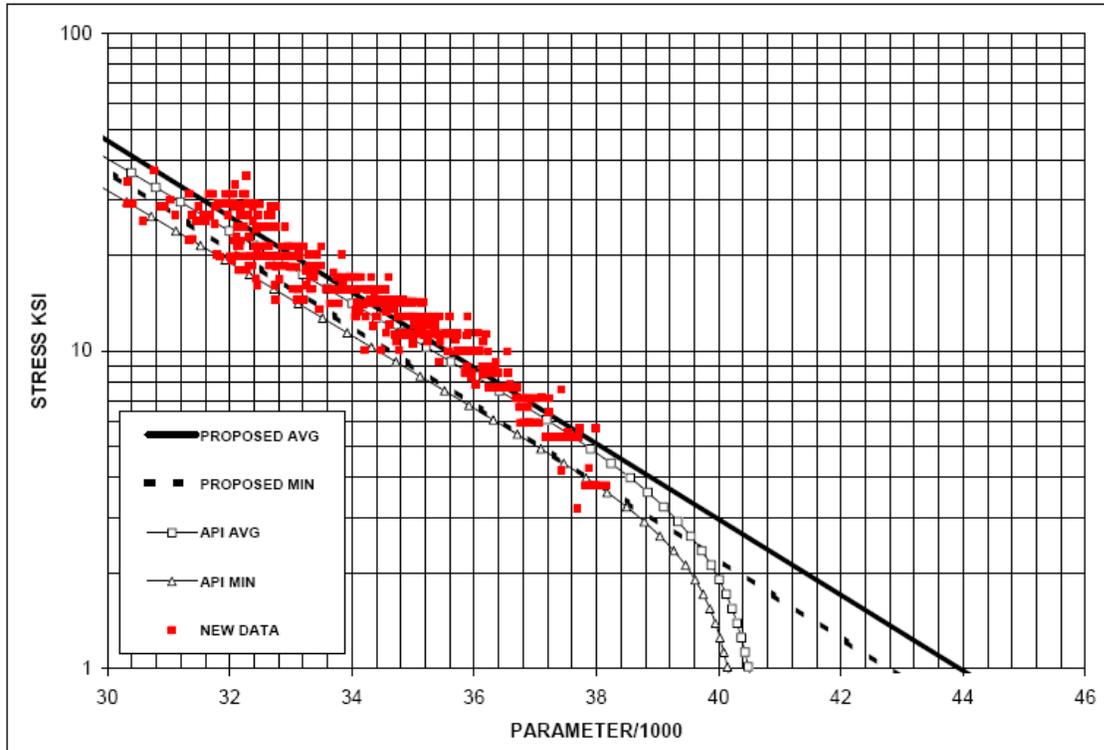
As noted in 1992 Report, the remaining life assessment performed in 1989-1990 should be invalidated for many reasons noted in the No-92-7349 report. One of the reasons is that the test condition is much higher than the operating condition. In such a case, it will be difficult to estimate reasonable remaining life by extrapolating the Larson-Miller parameter as shown in Figure 1 (Reference API 579 committee work Figure 13.5-2). A great deal of technology progresses have been made since 1991 regarding high temperature life assessment. (ref: Prager, M. "Development of Project Omega Method for the Life Assessment in the Creep Range" ASME PVP, 1994, Kim. DS & Mead, HE "Creep Remaining Life Assessment of Heater Tubes using Omega Method, ASME PVP 1999, API RP 579, 2007). American Petroleum Institute (API) Recommended Practice API RP 579 "Fitness For Service" and ASME "FFS-1" was published to estimate a more accurate remaining life assessment and testing. More realistic remaining life assessment can be made by utilizing the Omega method. In order to carry out the assessment, actual material data, process temperature and pressure should be given. Since no available data were provided, only sensitivity analyses were made to provide perspectives.

Figure 13.1 Inaccuracy of extrapolating L-M parameter at low stress range (ref: Figure 13.5-2 Larson-Millar Parameter of the Currently Employed API Curves Along With the Proposed Curves and New Data in US Customary Units: 2.25Cr-1Mo)
